Rework Second Generation Box Sensor for use with Ioline 68331 PCB Assemblies

3.27.2008
KSR

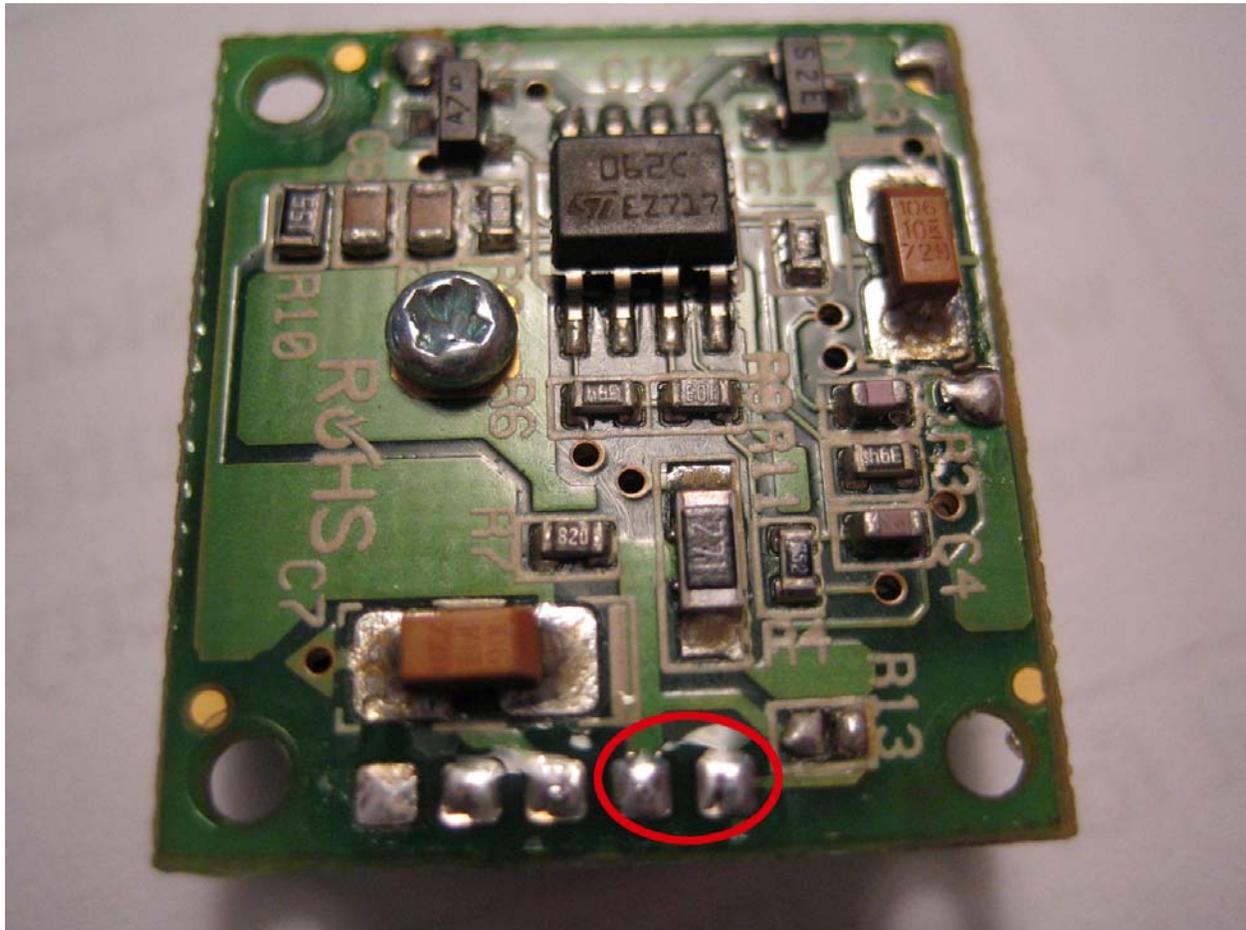
1. Remove the sensor from the assembly it is attached to (if required).
2. Find the Pin 1 and Pin 2 solder points on the back of the 5 pin connector as indicated in the image below.
