### **Y axis transmission adjustment**

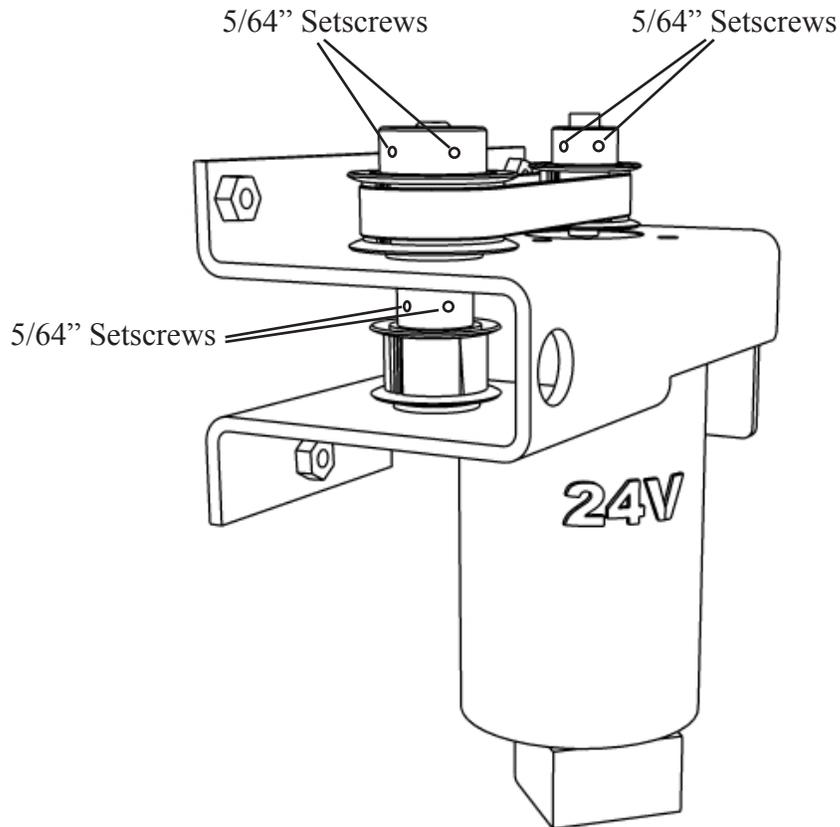
Symptom: Head alignment is still not lining up after going through the head adjustment procedure.

Tighten the setscrews shown on the Y axis transmission

Tools Required:

5/64" Hex wrench
